Ice/Frost/Debris Assessment For Space Shuttle Mission STS-32 (61-C)

January 20, 1986

Charles G. Stevenson
Gregory N. Katnik
The John F. Kennedy Space Center, NASA
and Robert F. Speece
Lockheed Space Operations Company
Kennedy Space Center, Florida

ICE/FROST/DEBRIS ASSESSMENT
FOR
STS-32 (61-C)
LAUNCHED
JANUARY 12, 1986

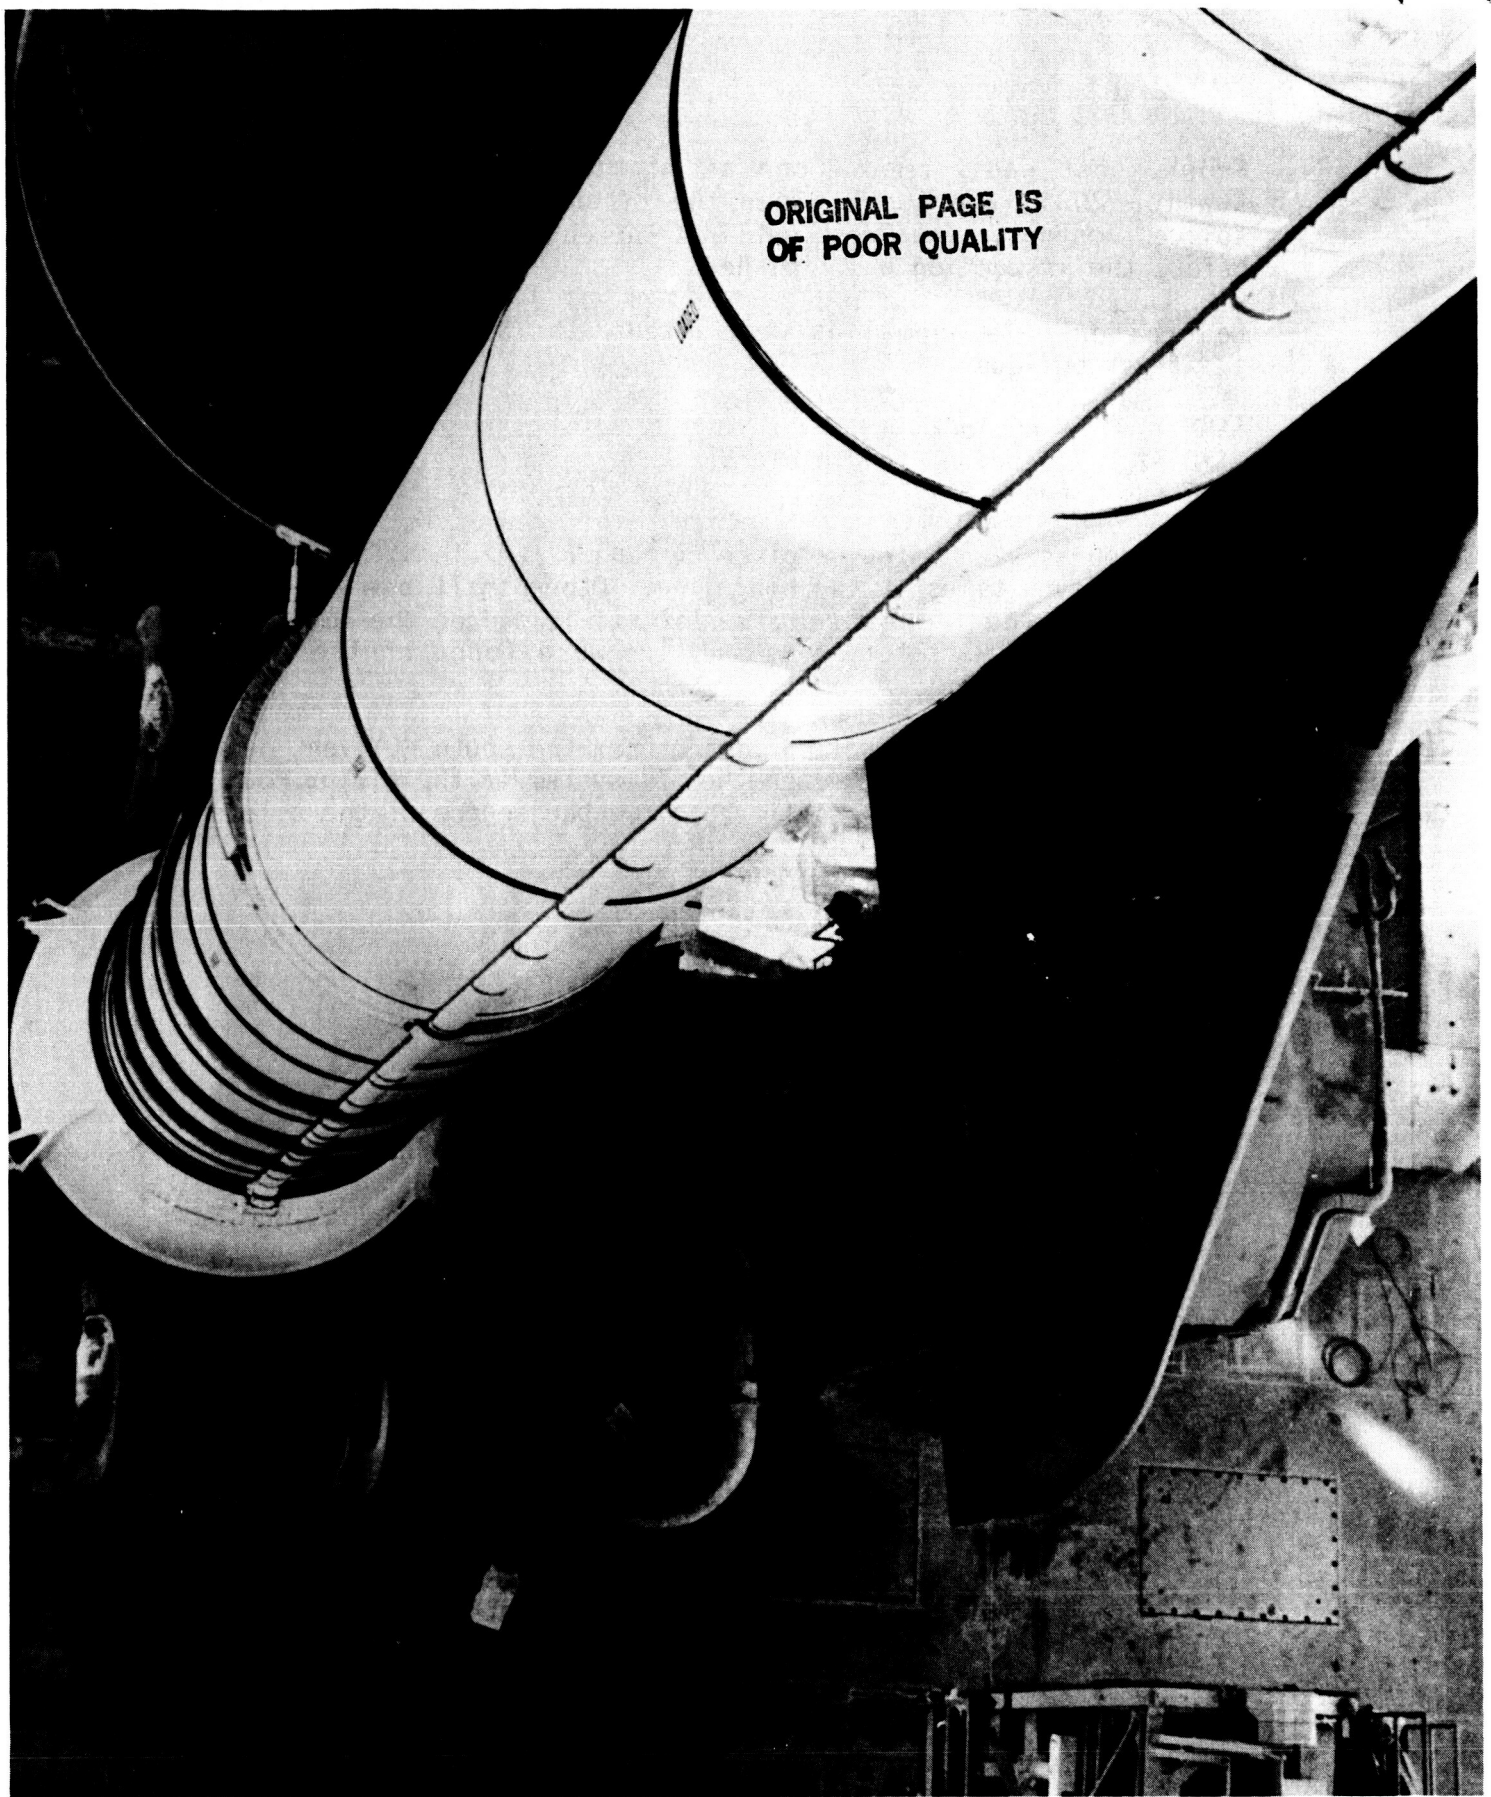
Two 6-8-inch icicles were hanging from the south GOX vent duct. These icicles were later observed on the OTV system in the firing room to break off and fall. They are believed to be the source of the tile damage on the orbiter's LH wing.

Damaged tiles on Orbiter LH Wing. View is from GOX Vent Arm just above ducts where icicles had previously formed.

No anomalies were observed on the STS-32 stack. The LH lower wing surface and outboard elevon damage, believed to have been caused by ice falling from the south GOX vent duct, had been repaired using TPS-311.

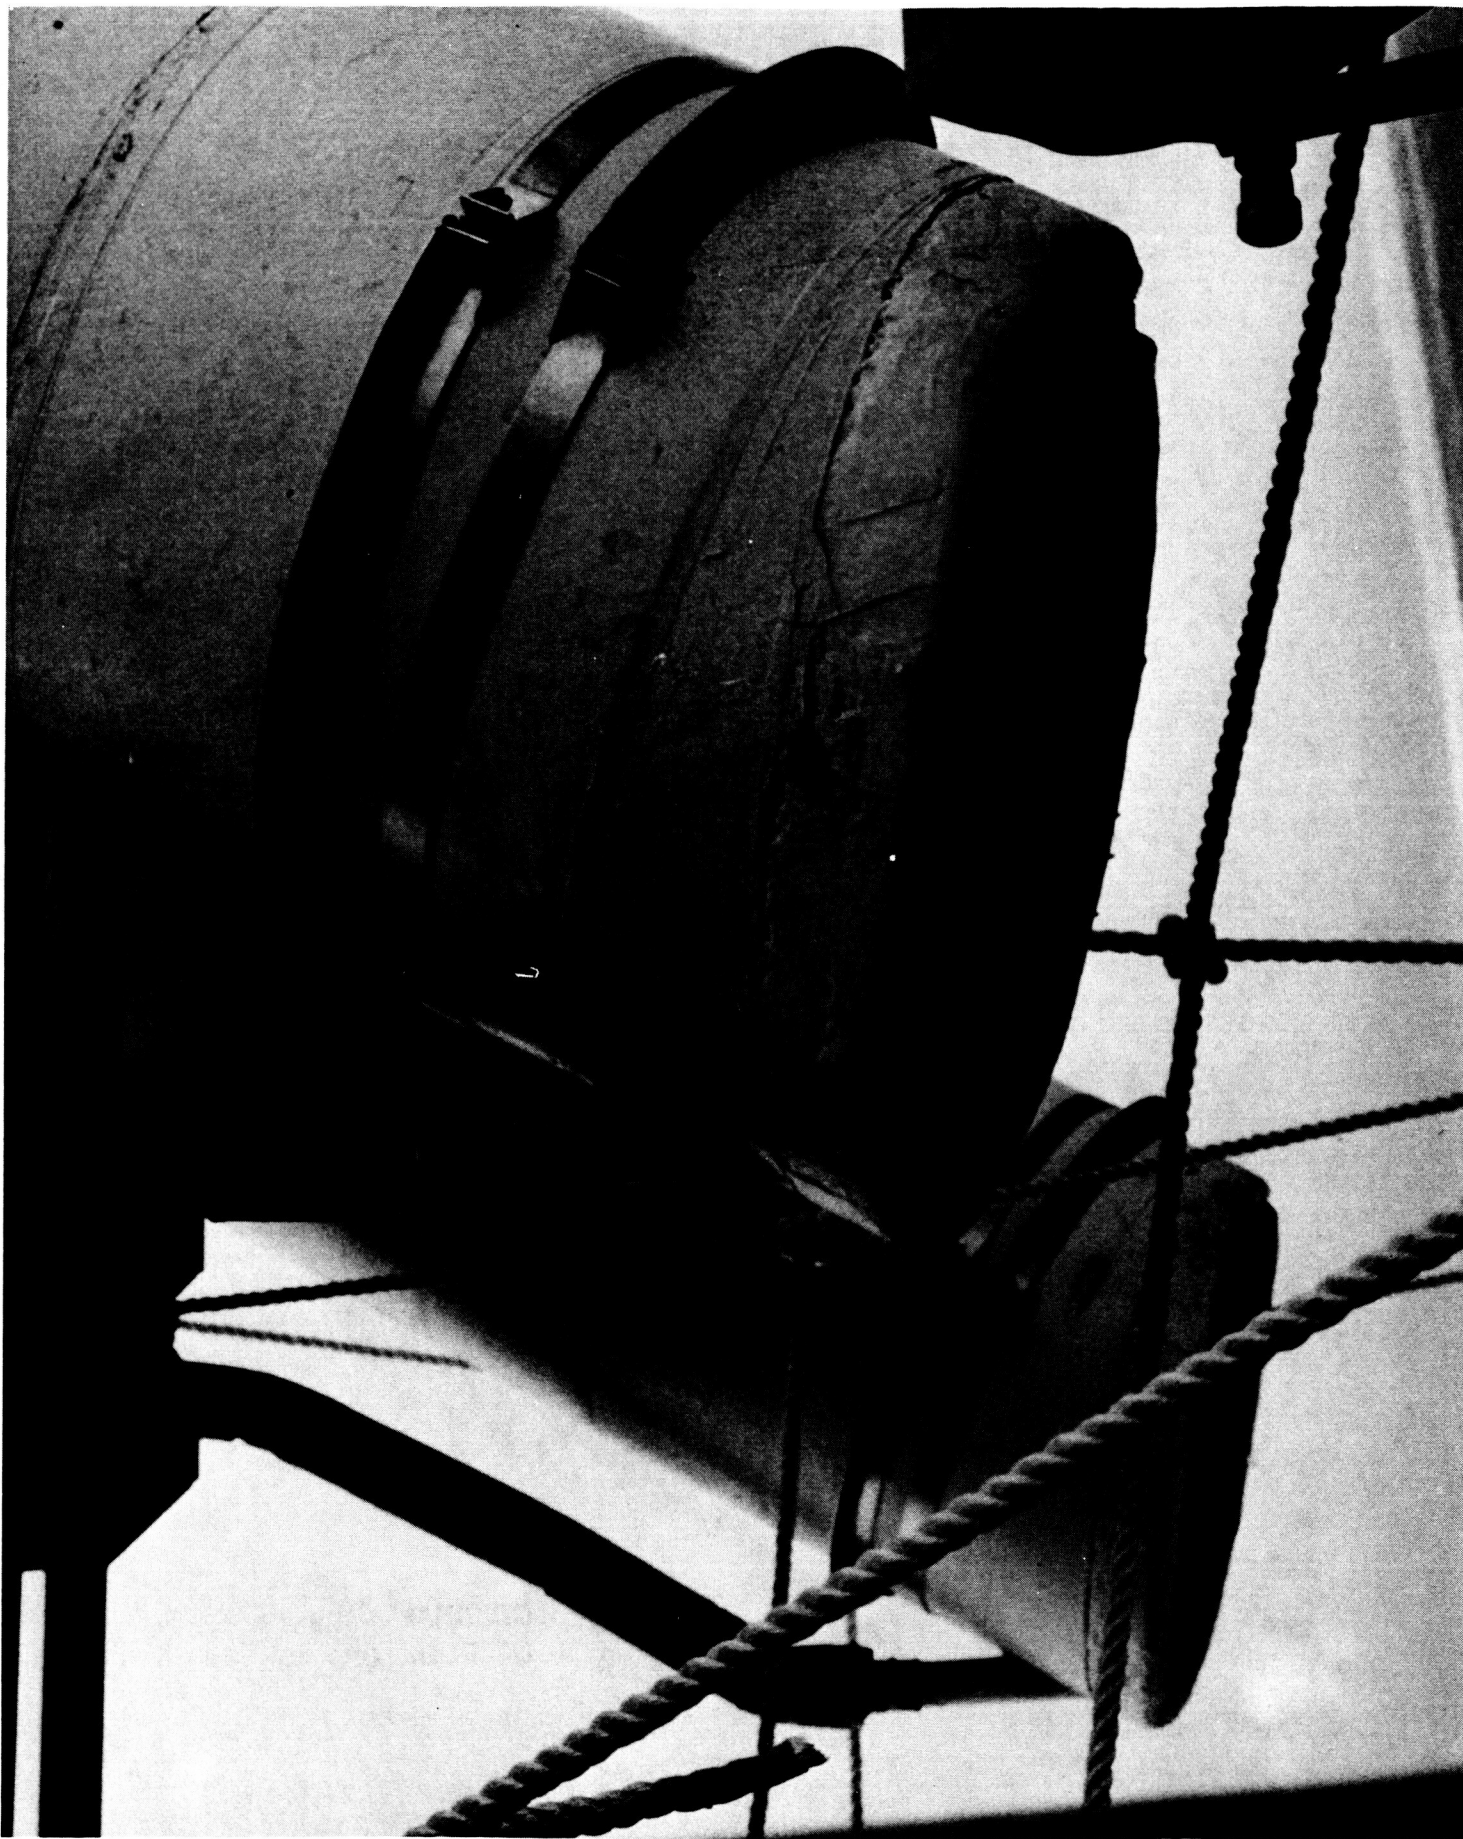
Modifications to GOX Vent Ducts to prevent icicle formation

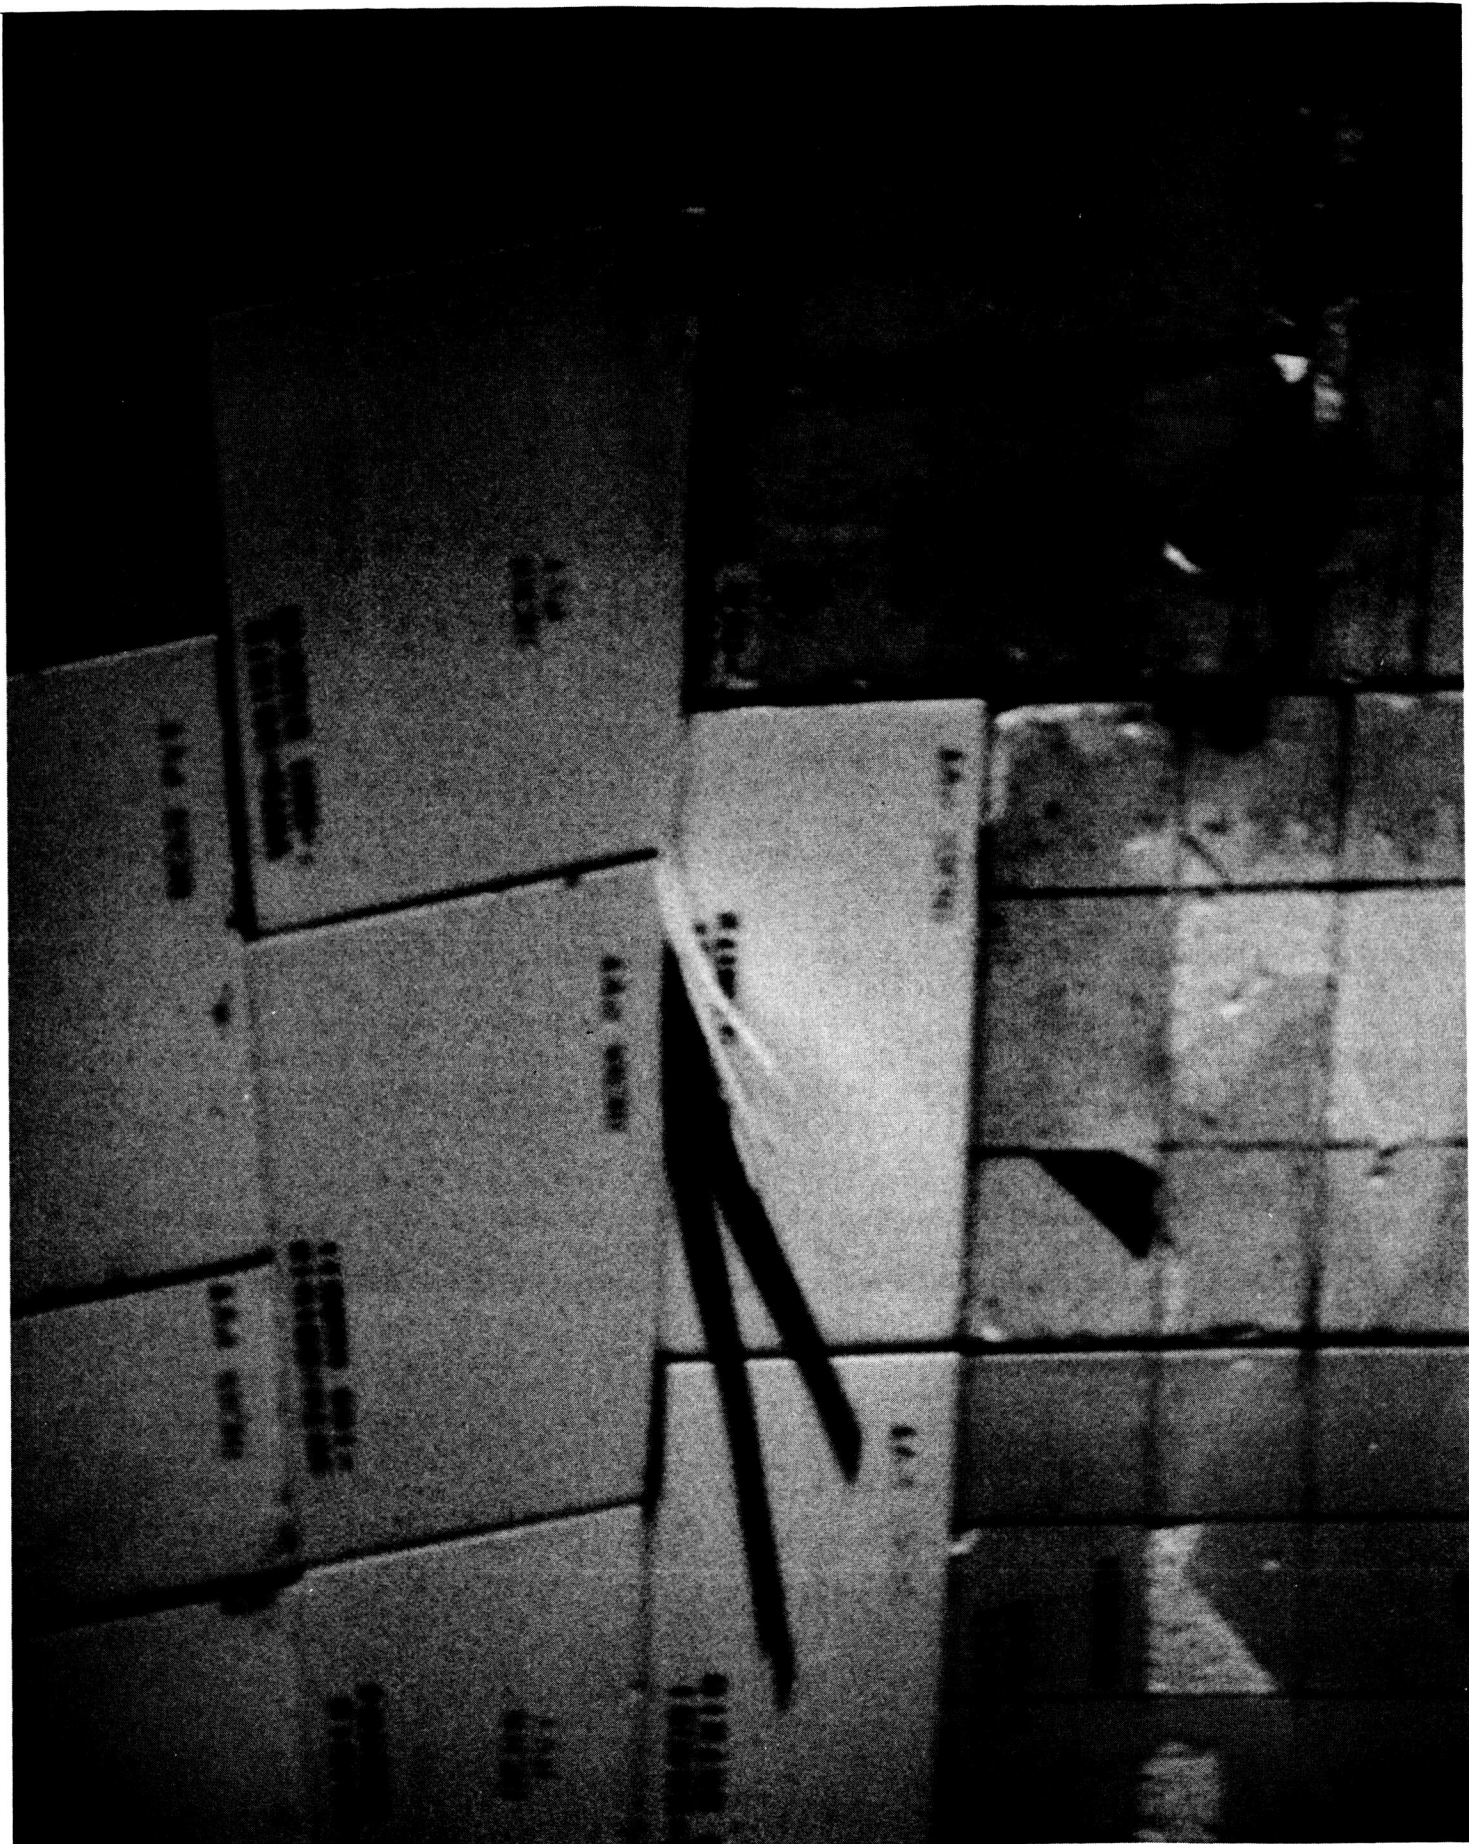
The only orbiter tile anomaly was a protruding gap filler below (aft) of the crew hatch.

Protruding tile gap fillers below Crew Hatch.

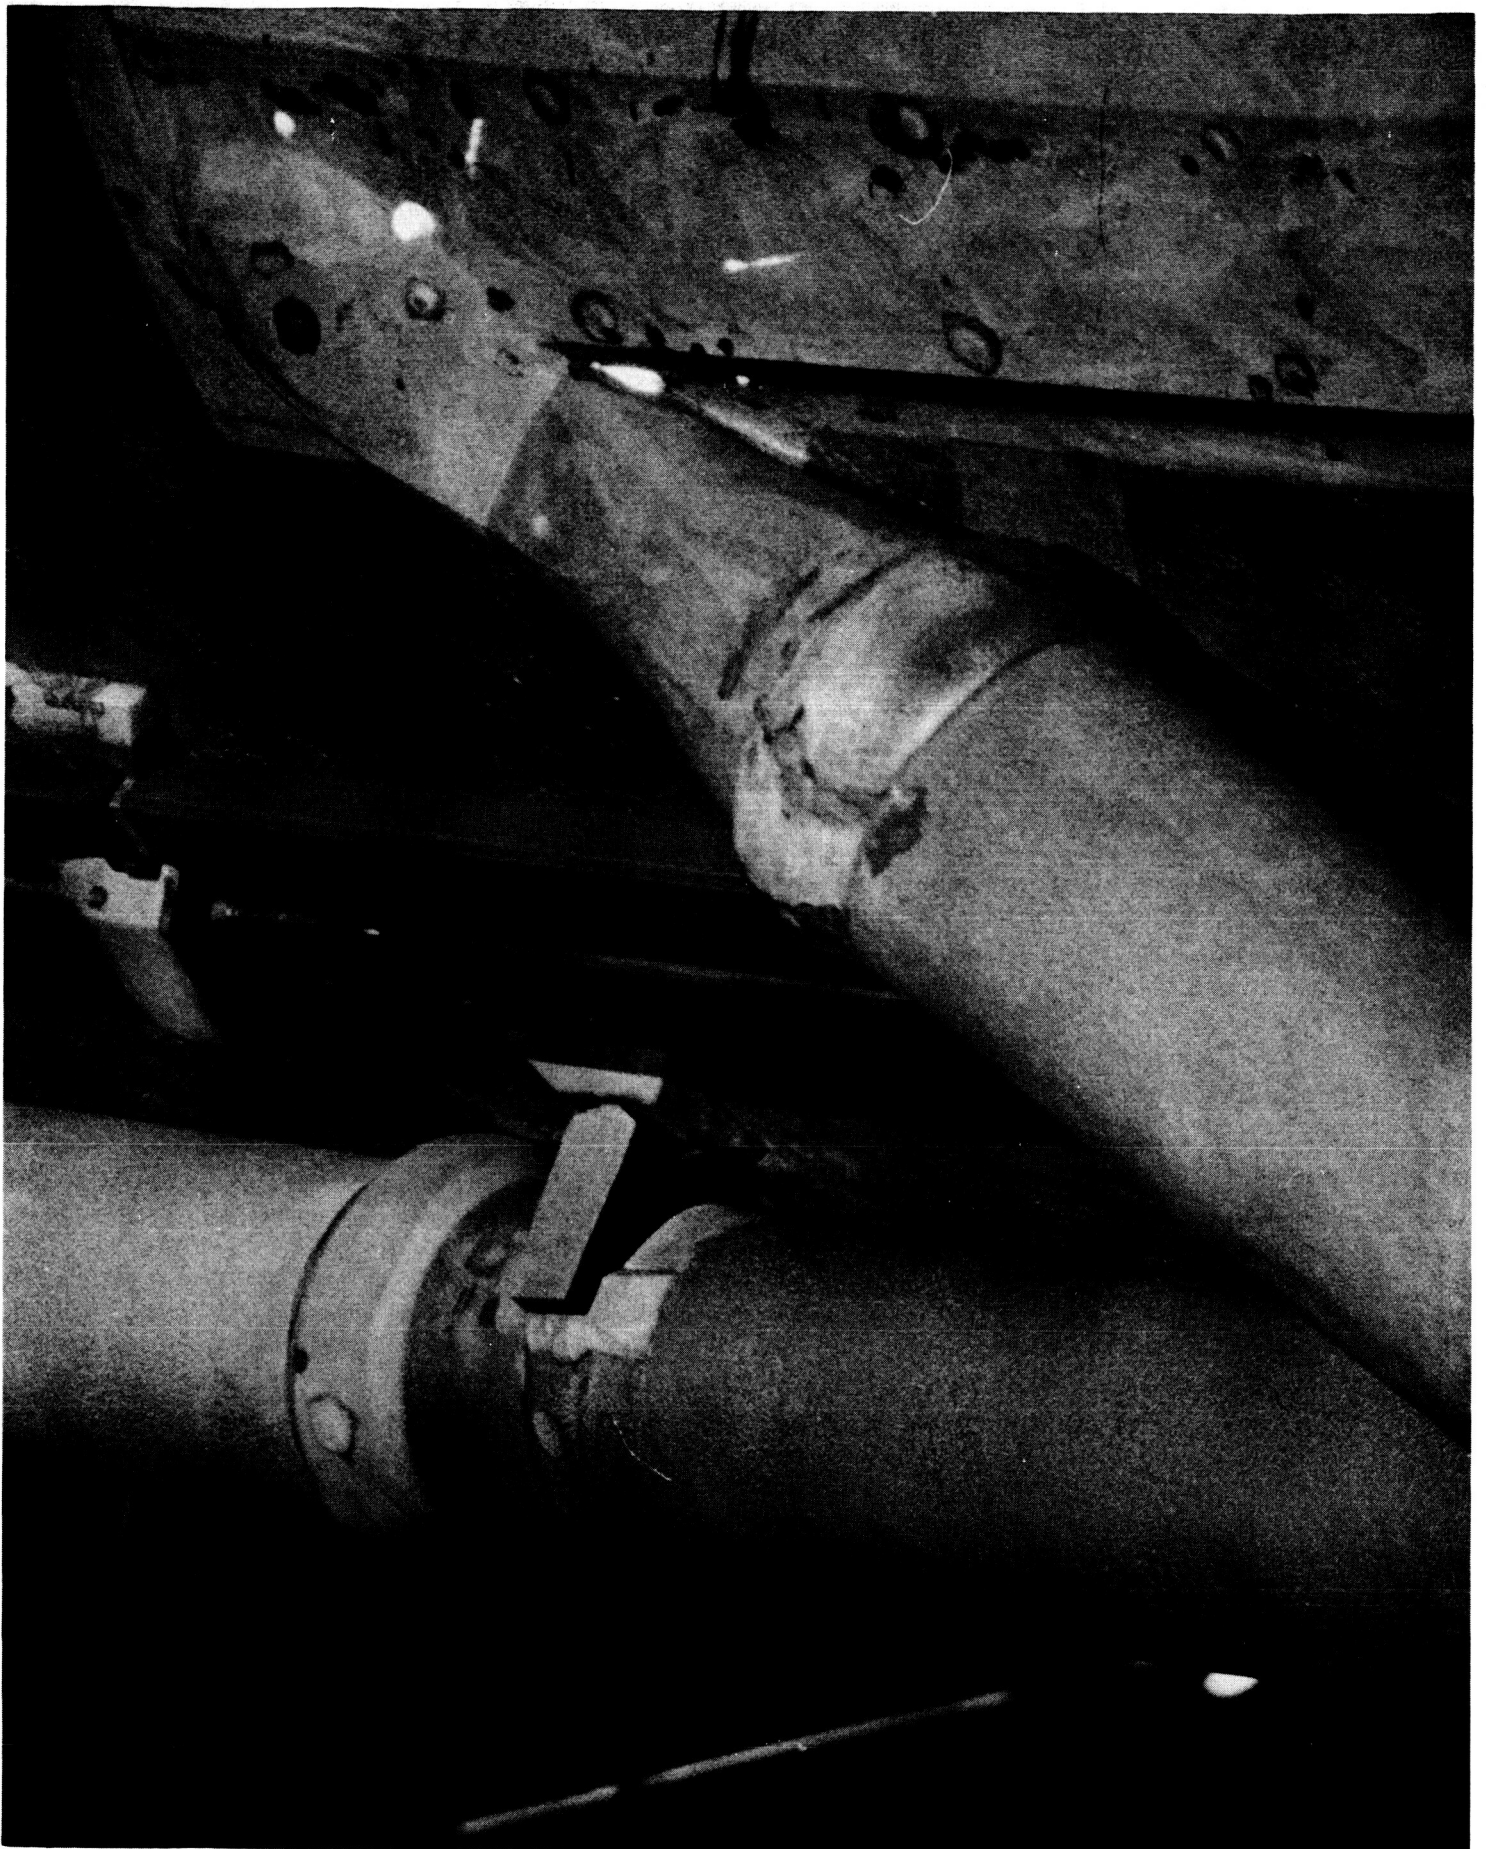
Ice/Frost spots on longeron to thrust strut interface

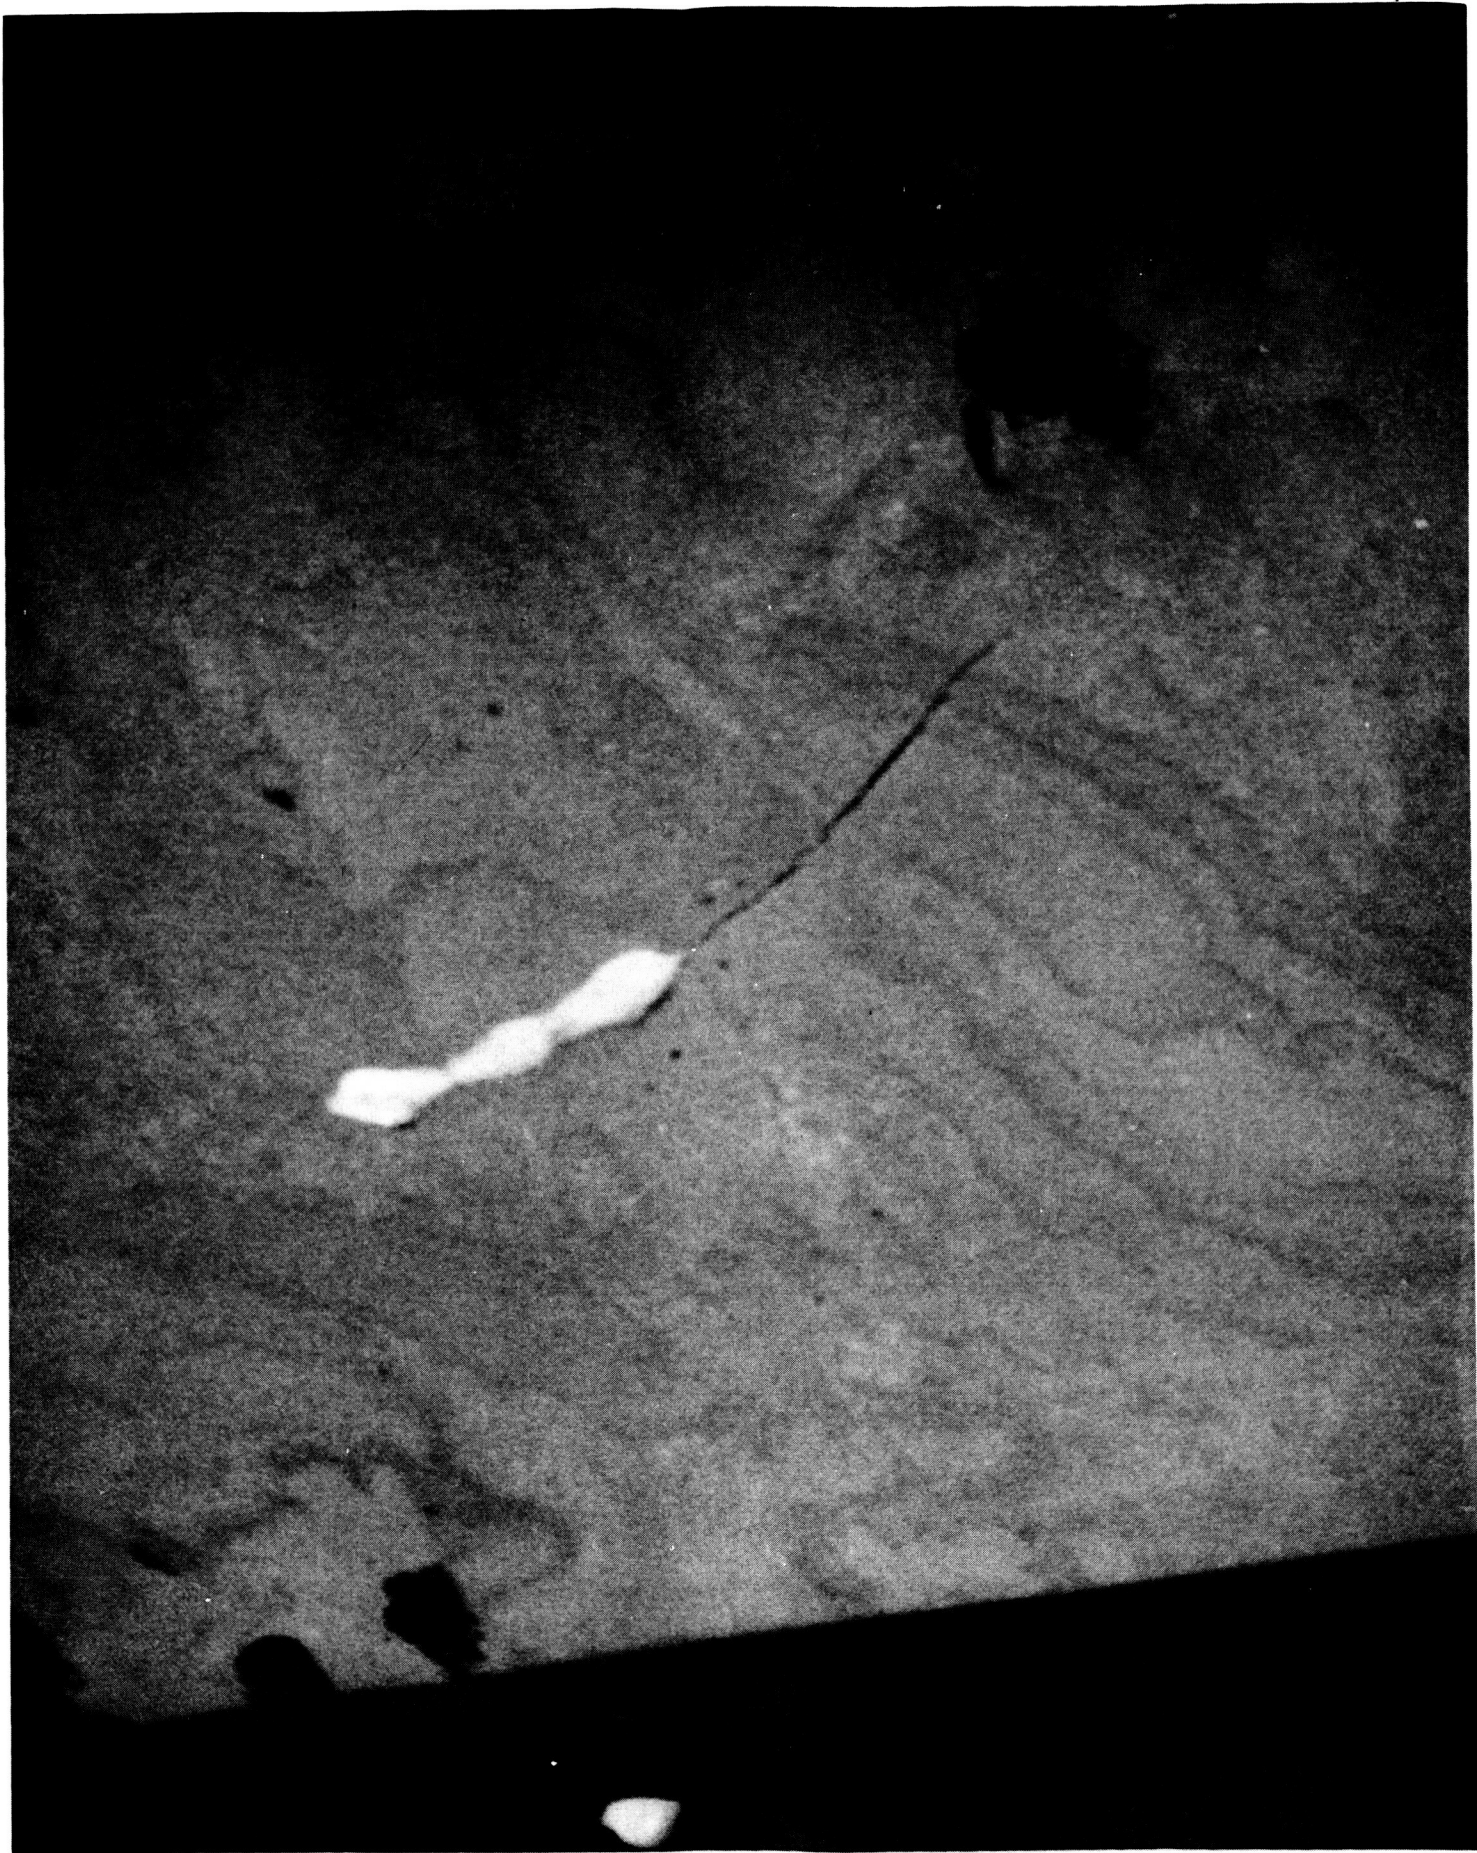
Frost formation on +Y longeron TPS crack

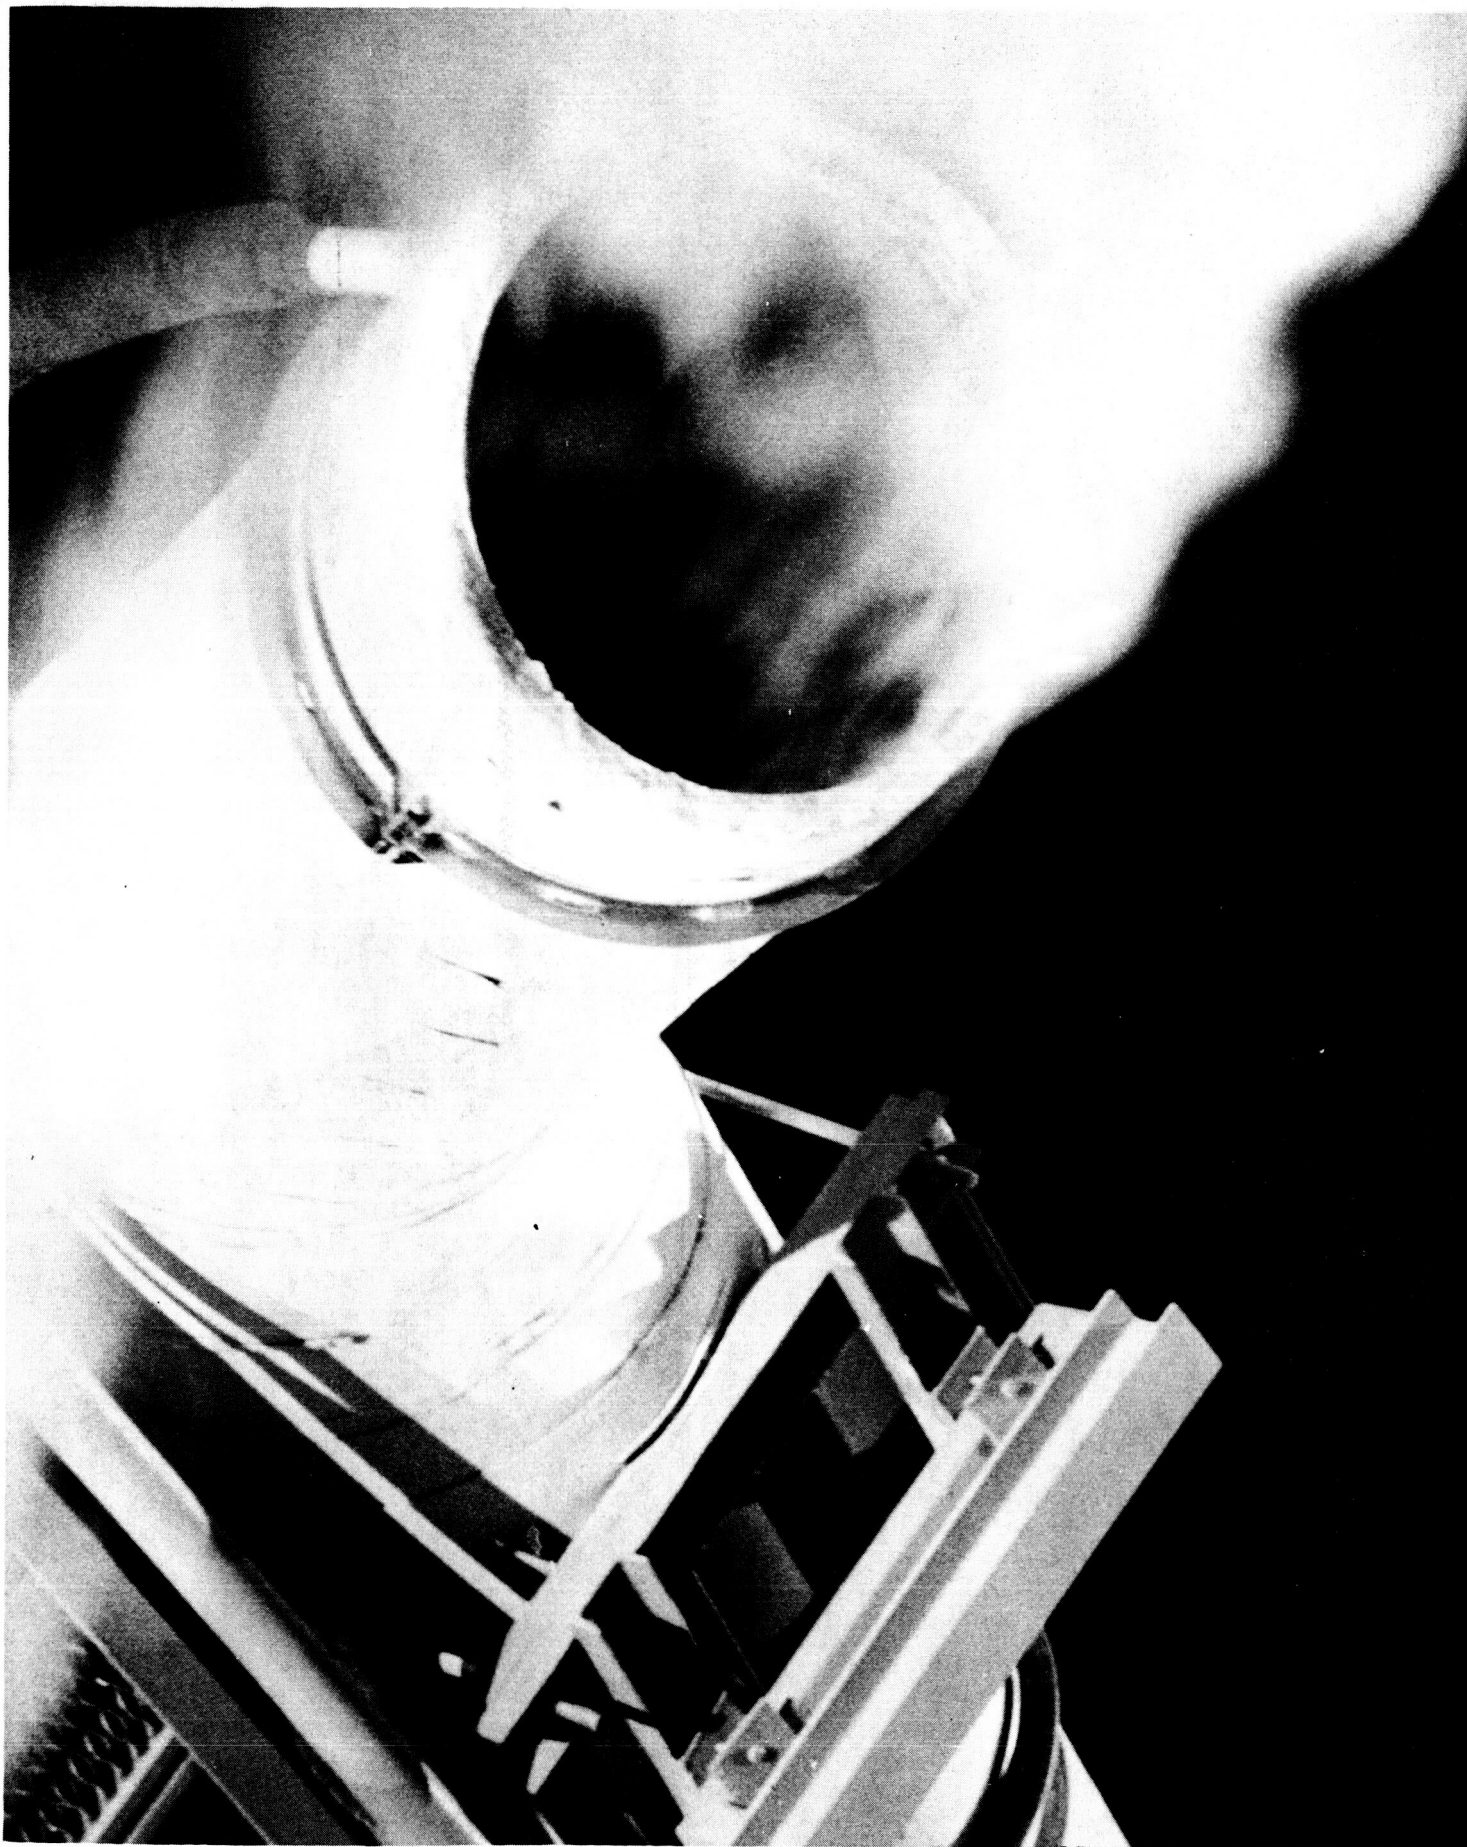
Icicles on south GOX Vent Duct

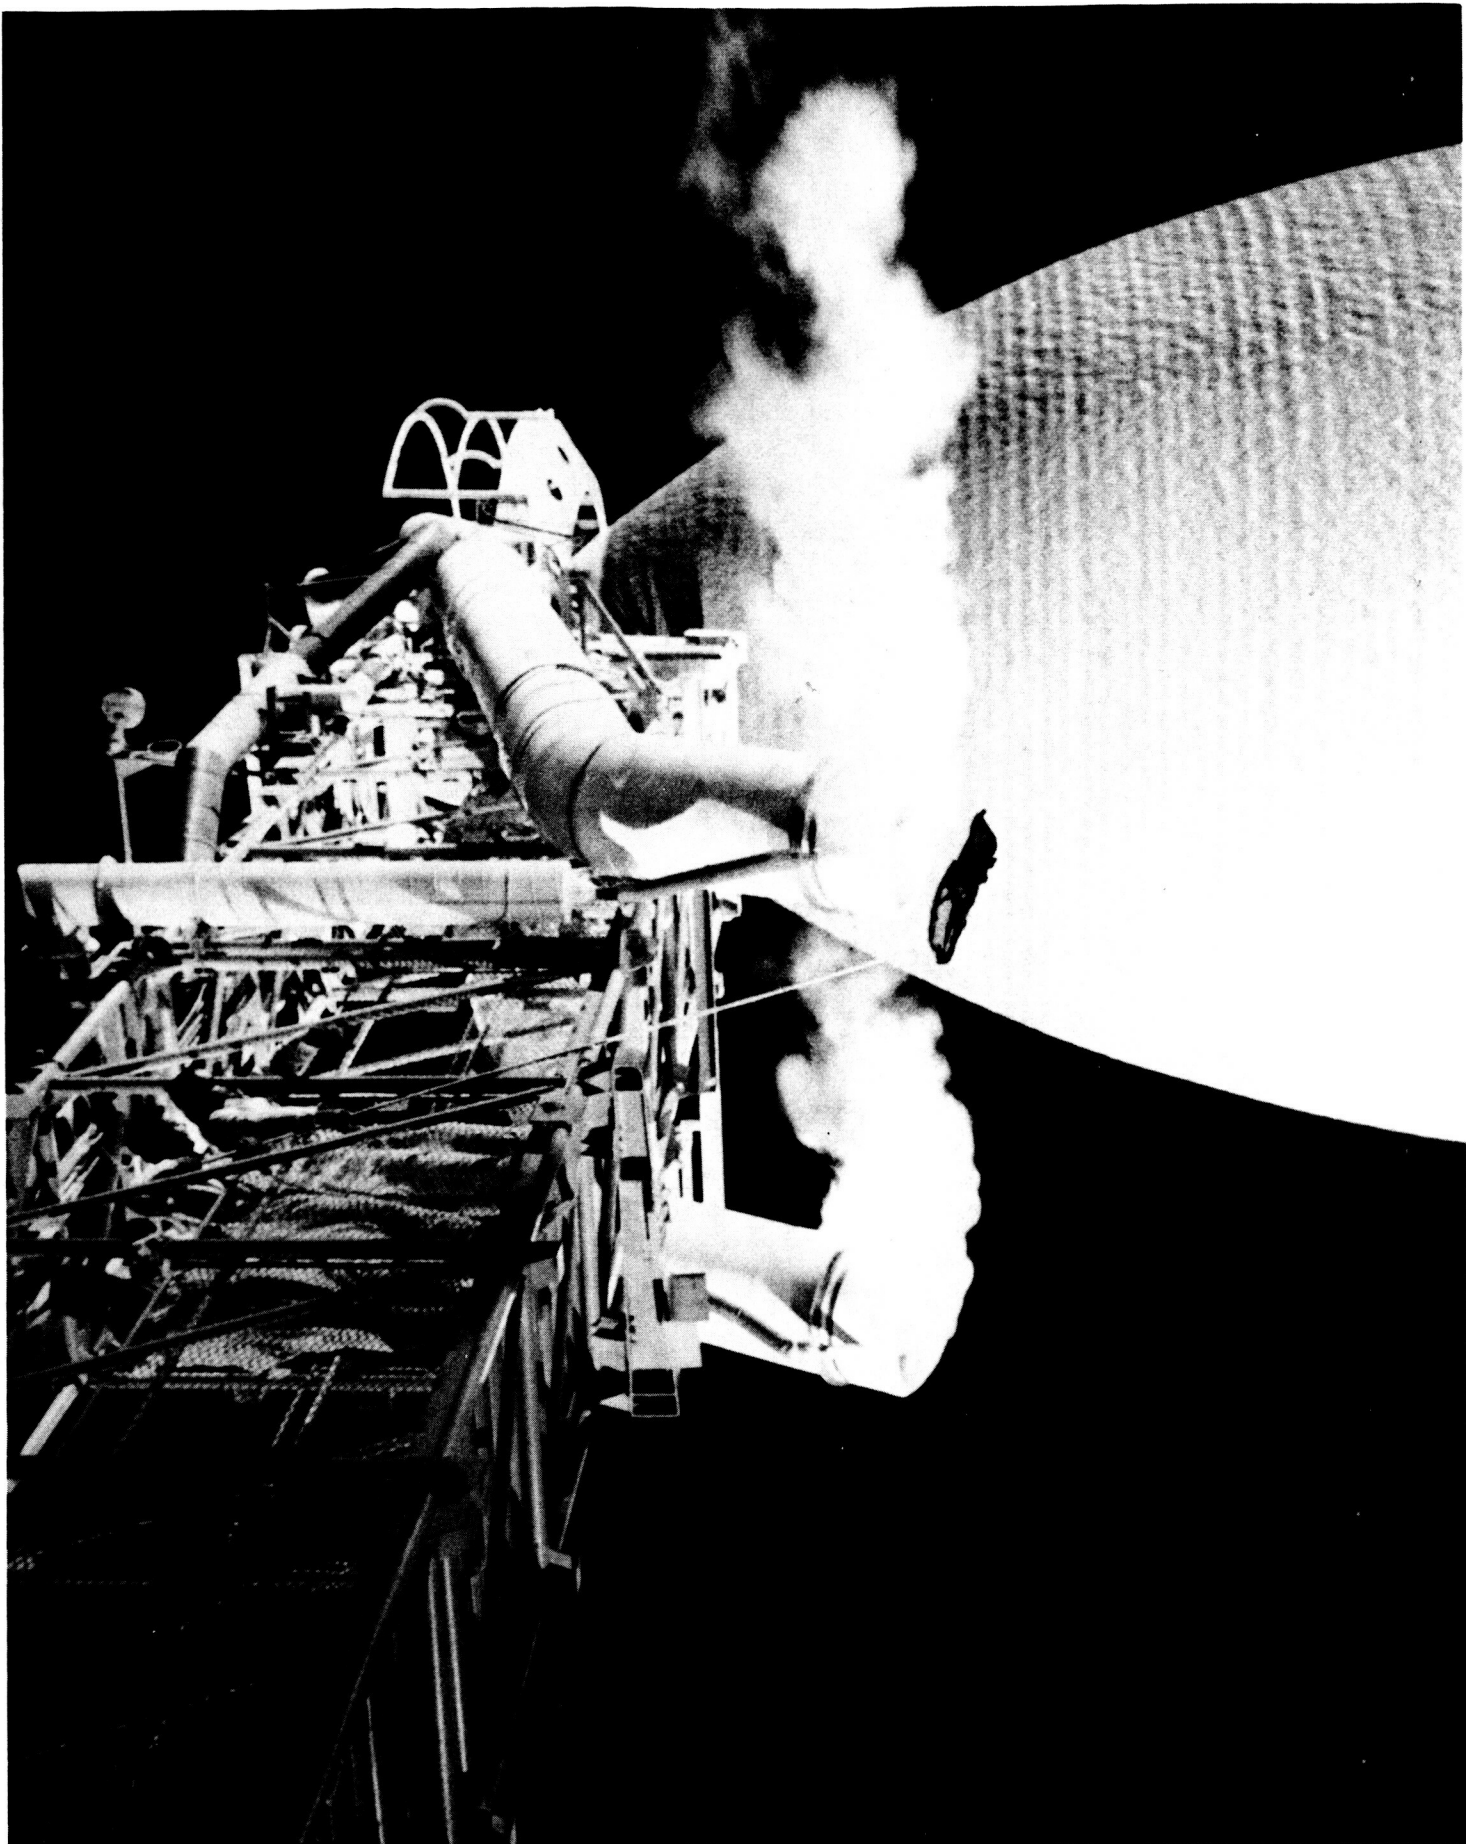
Removal of icicles using specially fabricated "Shrimp Net"

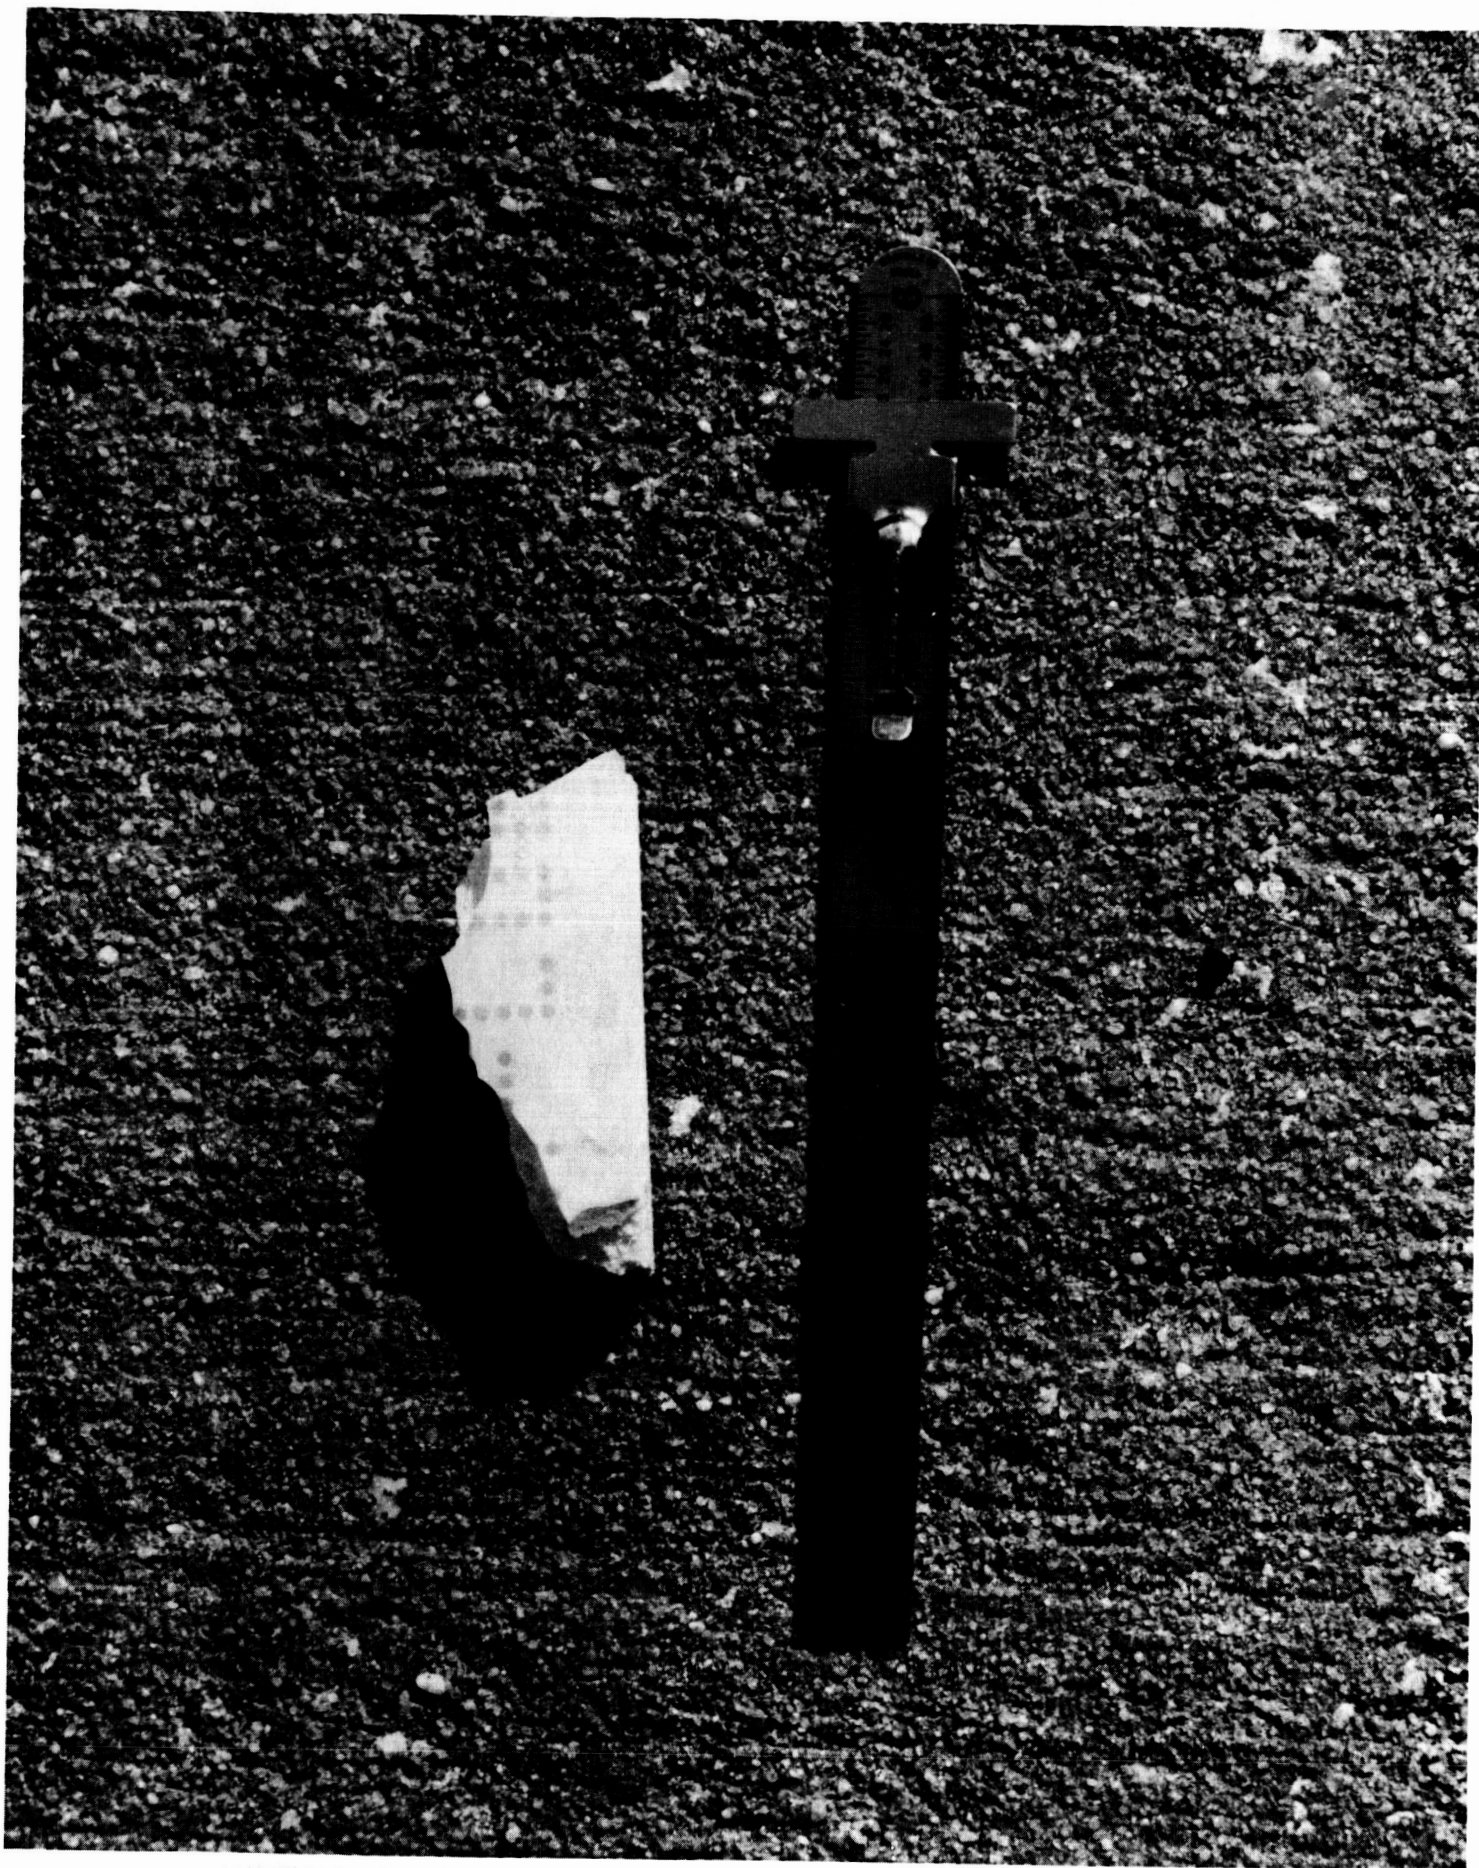
Piece of tile found on pad apron southwest slope
